# Water Compliance Inspection Report

**Compliance Evaluation Inspection Report**

**Nu-West Industries, Inc., Rasmussen Ridge Mine  
(a subsidiary of Agrium, Inc.)  
Soda Springs, Idaho**

**Inspection date: September 25, 2014  
Report completion date: January 7, 2014**

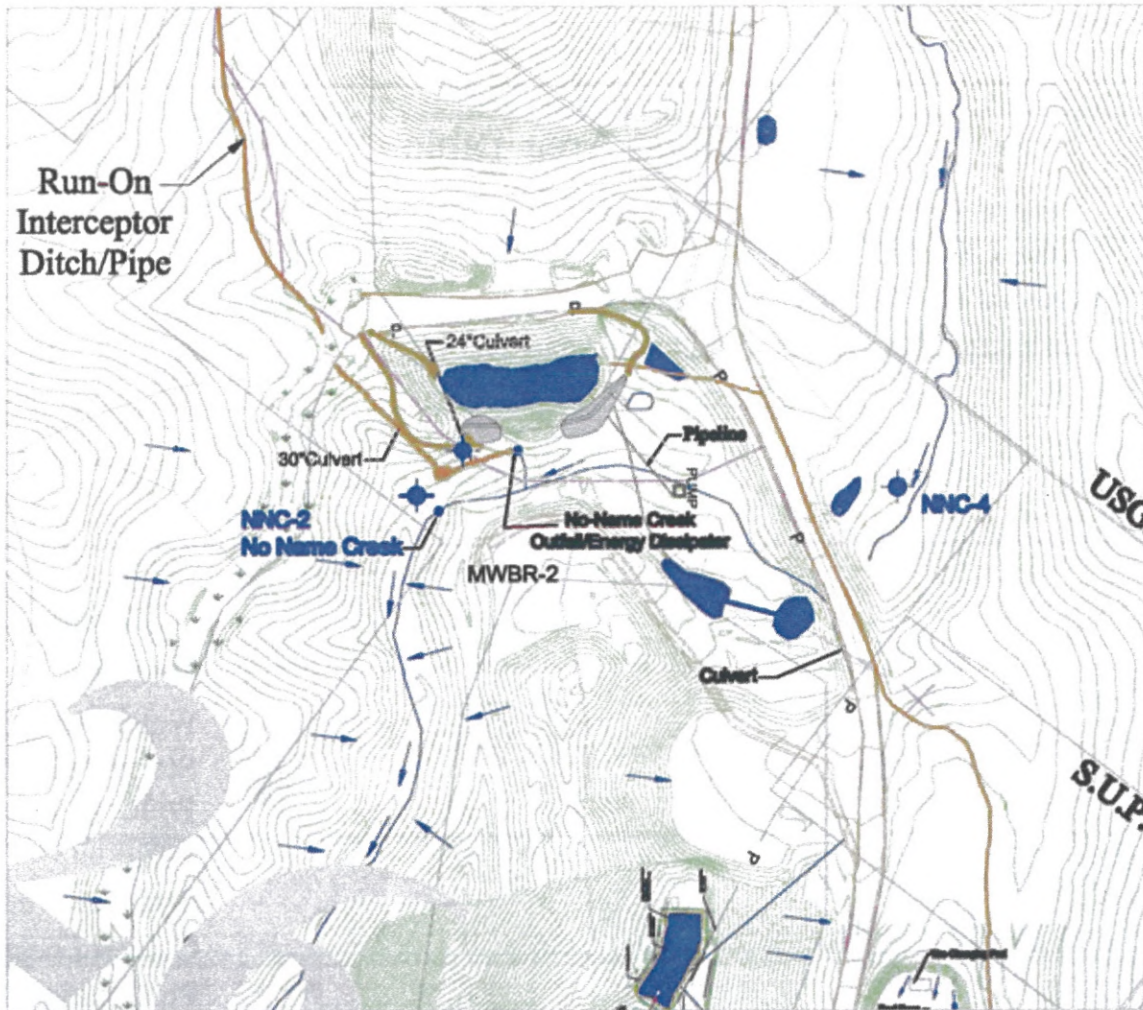
Photo No. 6 (Map provided by Agrum/Nu-west)  
Central pit details from SWPPP site map; In theory, all stormwater and leachate from the pump-back system is managed here.

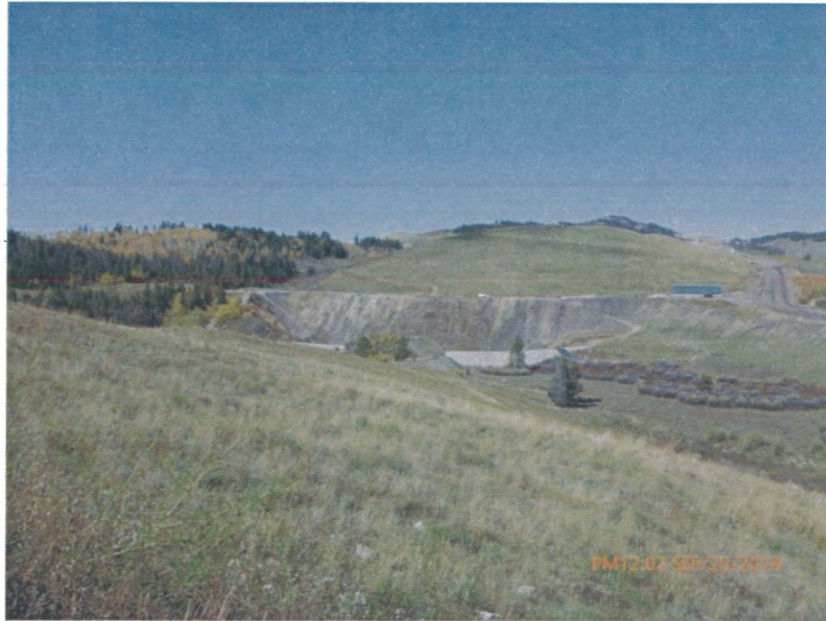
Photo No. 8 (P1000787)  
Facing north – the Central Pit Pond from the SED access road

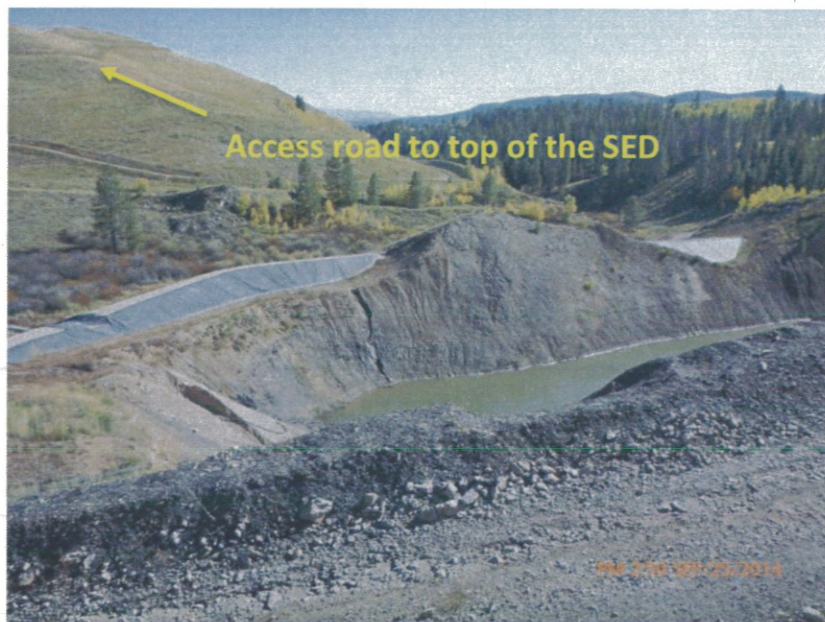
- 2) **Maintenance of BMPs:** As described in Sections VIII and IX of this report, I noted that most of the erosion check dams (rock and wattles) located on the bank-side of the access road to the top of the SED had been overtopped with sediment (see Photos 10-12). This maintenance issue involving BMPs does not appear on any of the routine inspection reports for the mine.

Photo No. 9 (P1000819)  
Facing south – this photo, made from a shelf above the Central Pit Pond, shows the access road to the top of the SED.

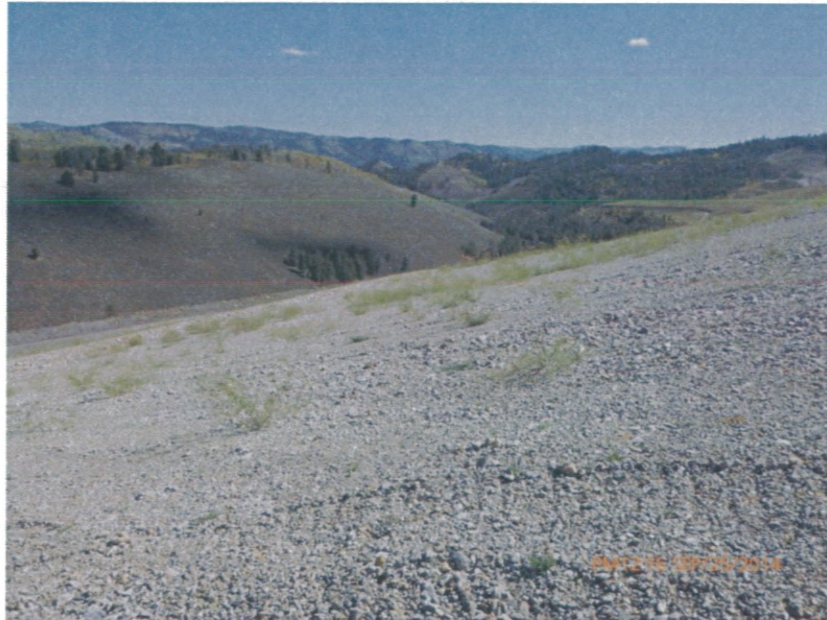
Photo No. 15 (P1000792)  
Facing south – the rock-armored side of the FMTE cover

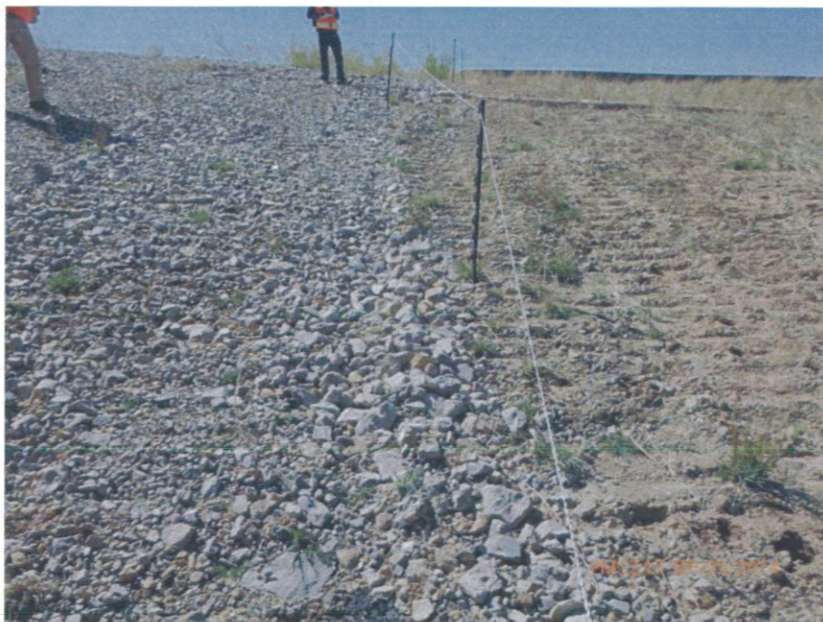
Photo No. 16(P1000793)  
Facing west – the boundary between the vegetated and the armored side of the FMTE is apparent in this photo.

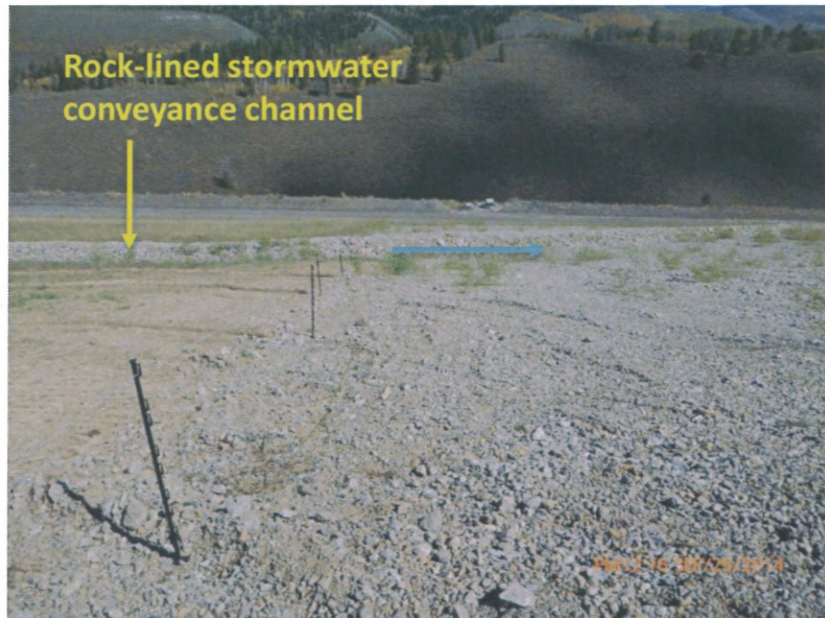
Photo No. 17 (P1000791)  
Facing east /looking downward – the boundary between the vegetative and the rock-armored side of the FMTE is obvious.

- Yes, significant erosion has occurred in 2013 and 2014 following the spring snowmelt and late summer thunderstorms on the soil cover portion of the FMTE. Repairs have been conducted during the 2013 and 2014 field seasons. The most recent significant erosion event occurred following the record-high precipitation event that occurred on August 23, 2014.

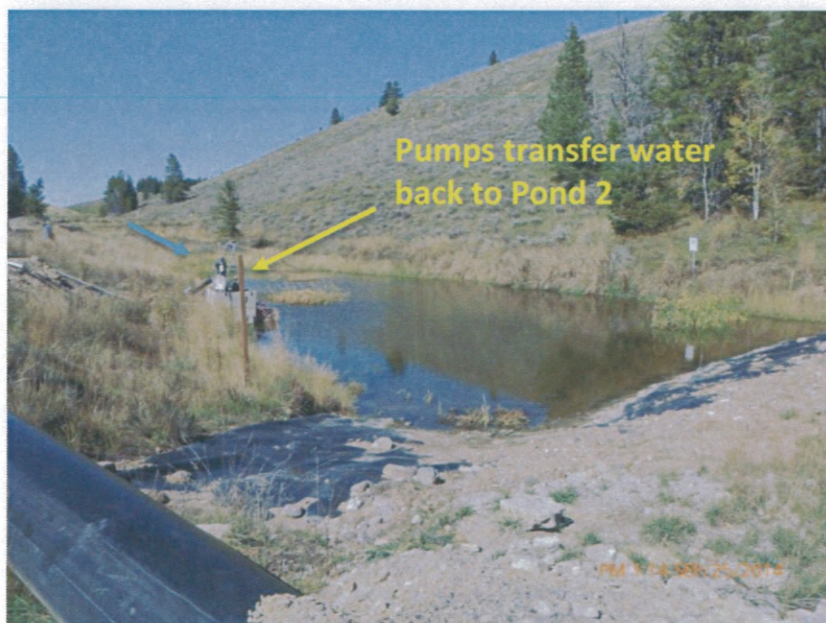
Photo No. 21 (P1000801)

Facing north – Pond 5 is the last in a series of water management ponds in the South Fork of Sheep Creek drainage; water from this pond is automatically pumped back to Pond 2 when water reaches a certain level.

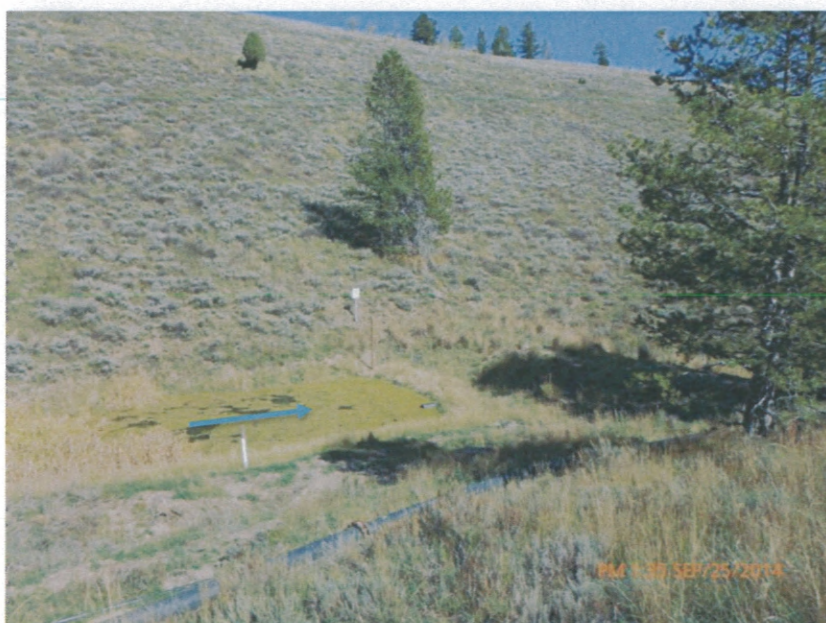
Photo No. 28 (P1000808)  
Facing east – pump-back Pond 3

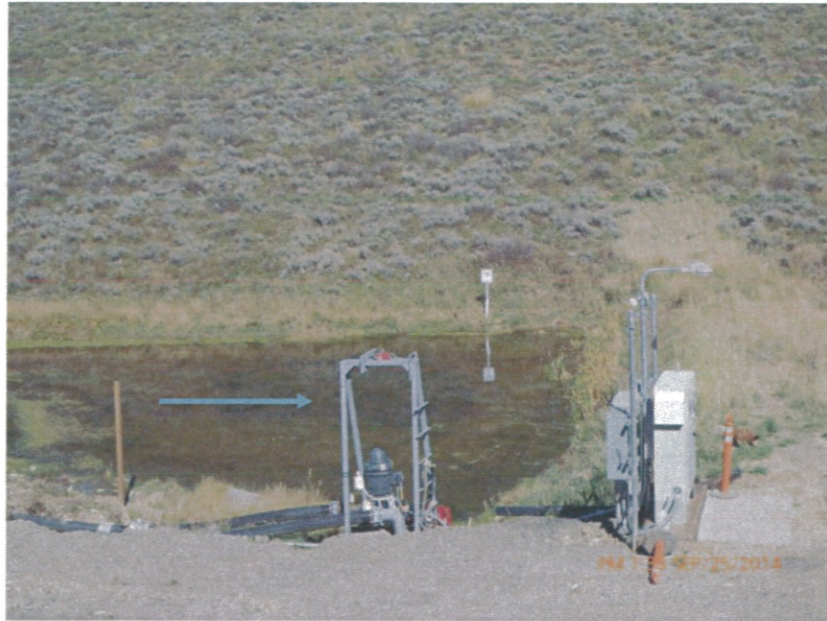
Photo No. 29 (P1000809)  
Facing east – pump-back Pond 2; water from this pond is  
automatically pumped to the Central Pit Pond. .

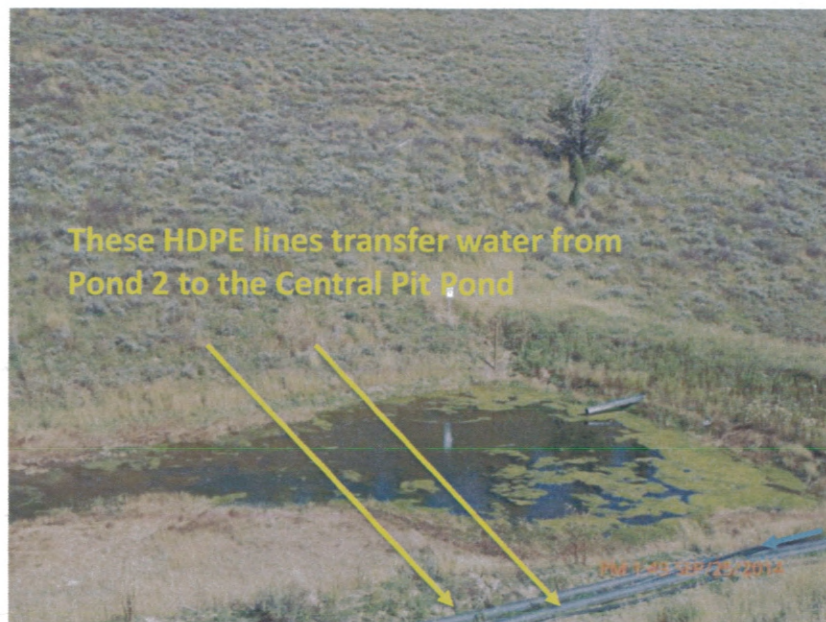
Photo No. 30 (P1000811)  
Facing southeast – pump-back Pond 1

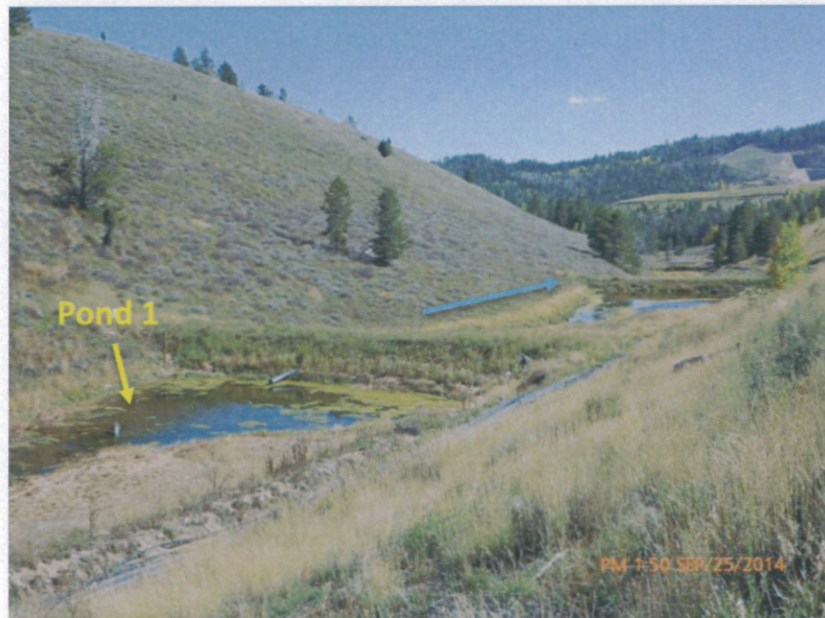
Photo No. 31 (P1000812)

Facing southeast – pump-back Ponds 1 & 2

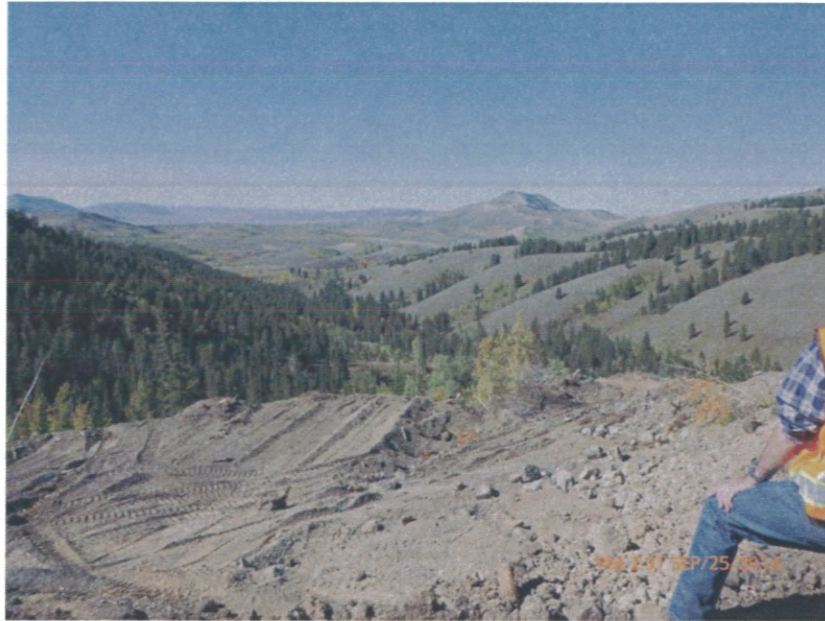
with the Forest Service and the Bureau of Land Management to obtain a permit that would allow for mine expansion into Reese Canyon (see Photo 33). He also indicated that Nu-West had recently submitted a “*North Rasmussen Ridge Mine Reese Canyon Creek Insignificant Degradation Analysis*” to IDEQ as part of the expansion plan (see Attachment D).

Photo No. 33 (P1000817)  
Facing north – Reese Canyon; Nu-West has plans to mine in this area as well.

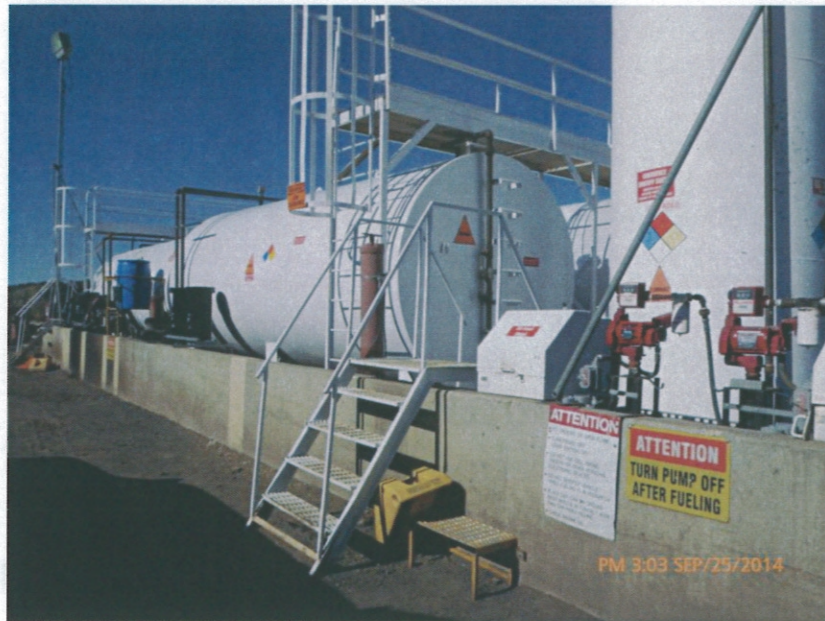
Photo No. 35 (P1000820)  
Facing northeast – the fuel farm at the NWRR mine
